4.3. Intersection with Veterans Parkway

Table 13. Safety Findings for Elma G. Miles and Veterans Parkway Intersection

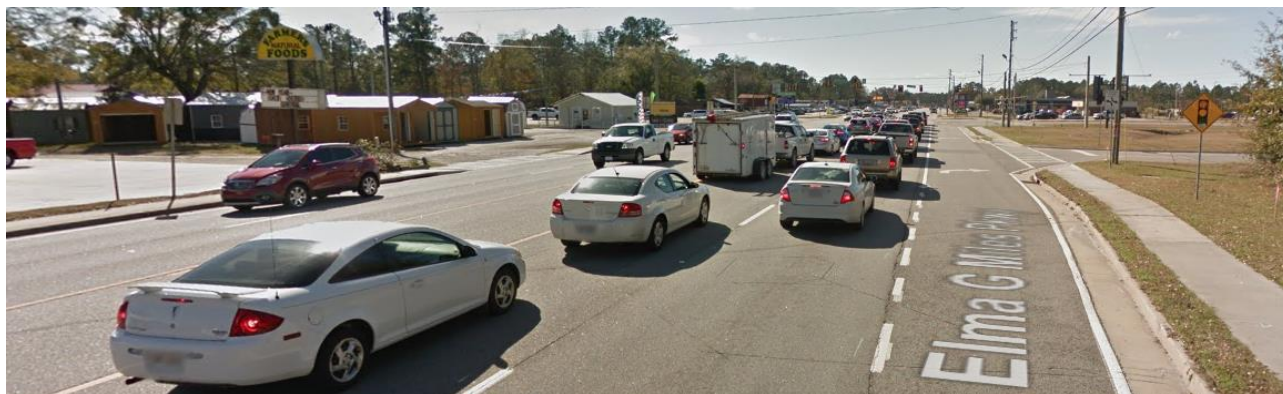
Figure 27: View of Westbound SR 196 at Veterans Parkway Intersection

Approach speeds to the intersection were noted to be relatively high during the RSA process, a concern that is evidenced by the fact that 140 of the 187 crashes that occurred at this location were rear end in nature. The combination of the relatively high approach speeds with the queues that form during the peak hours at this location (shown in **Figure 27**) compound this concern, leading the noted pattern of rear end crashes.

The existing W3-3 Signal Ahead warning signs are beyond their useful service life; replacing these signs would greatly improve their conspicuity, especially under dark conditions. Further, relocating these devices farther upstream would provide additional guidance to drivers of the upcoming signalized intersection. This would directly help to address safety issues #18, #21 and #25. It should be noted that the bicycle lane alternative identified for the eastern portion of the SR 196 corridor would also help to address safety issue #18 related to high approach speeds on the western leg.

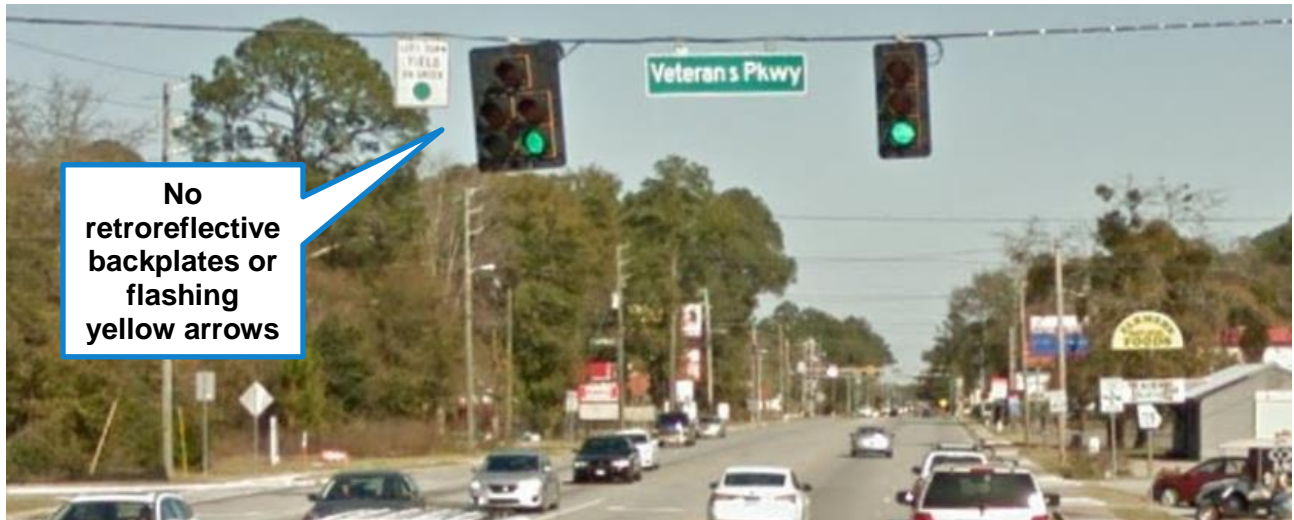
Figure 28: View of Eastbound Signal Heads at Veterans Parkway Intersection

The existing traffic signal heads at the intersection do not include retroreflective backplates (shown in **Figure 28**). Additionally, four-level flashing yellow arrow signal heads are not included for the eastbound and westbound left-turn movements, as the existing signal heads employ the dog-house design. Supplementary signal heads are also not present, which may help to provide additional guidance to drivers attempting to complete left-turn movements.

The installation of retroreflective backplates, supplementary signal heads, and flashing yellow arrows for the eastbound and westbound left-turn signal heads would also help to improve traffic signal conspicuity, providing additional guidance to drivers in this complex visual environment. It should be noted that the recommended signal treatments may not be appropriate in combination with recommendations #21 and #23. A review of the existing signal timing may also identify opportunities to reduce queuing to address safety issue #21.

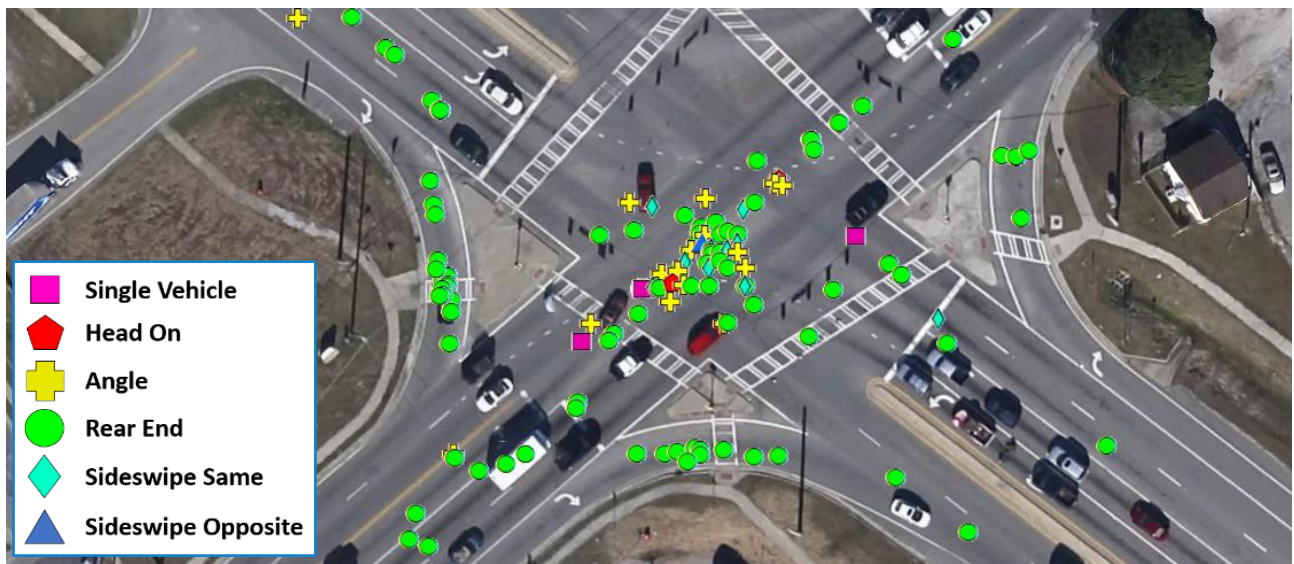
Figure 29: Pattern of Rear End Crashes in Channelized Right-Turn Lanes (2012-2016)

The existing raised concrete channelizing islands were implemented with a higher deflection angle that can result in drivers having to look over their shoulder to observe conflicting traffic. As a result, a pattern of rear end crashes within the channelized right-turn lanes was observed during the five-year study period (Figure 29).

The implementation of 30-60-90 degree raised concrete channelizing islands would represent a significant improvement over the existing condition, helping to address the pattern of rear end-type crashes shown in **Figure 29**. Consolidating driveways within the functional area of the intersection, specifically the gas station driveways located on the northern leg, would directly help to address the crash pattern shown in **Figure 31**.

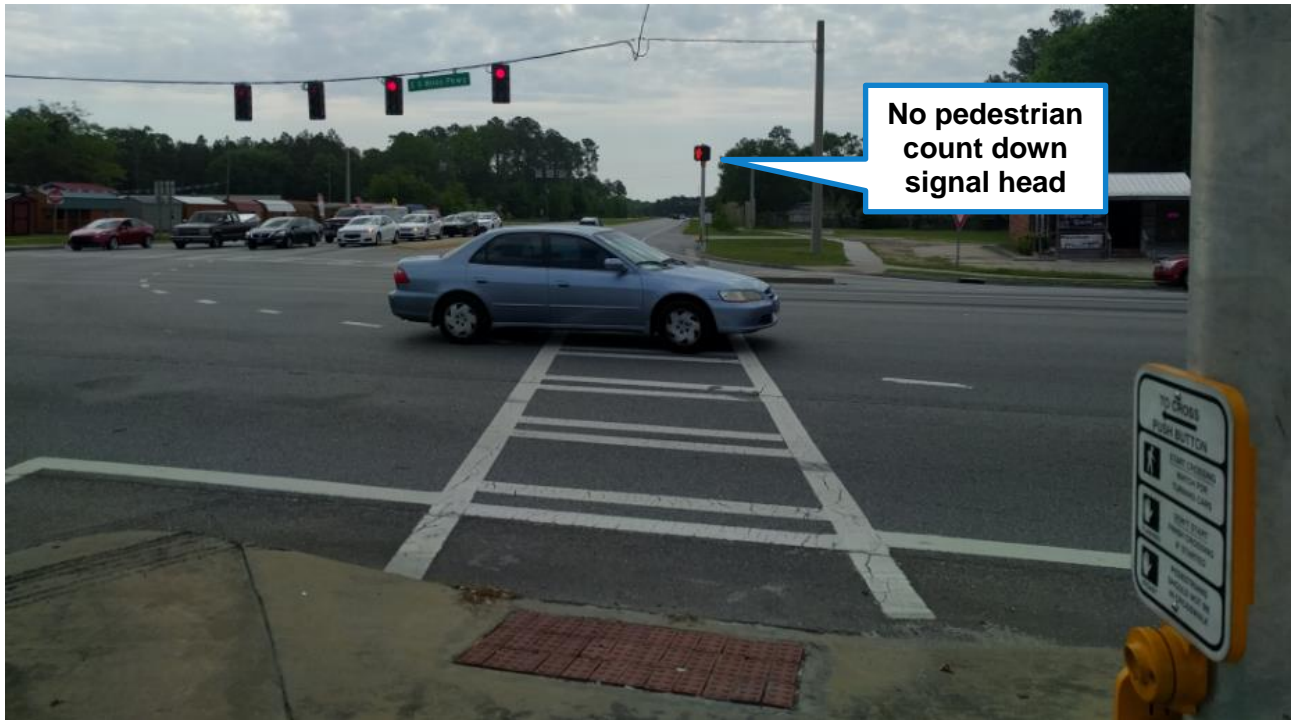
Figure 30: View of Pedestrian Signal Head and Push Button Actuation

While pedestrian signal heads and push button actuation are present at this location, pedestrian count down signal heads have not been included (Figure 30). The RSA team determined the crosswalks and ADA-complaint ramps present at this location are in good condition.

Given the presence of significant non-motorized traffic at this location, treatments to improve pedestrian and bicycle safety performance are a critical element of this RSA. Pedestrian count down signal heads have been shown to improve non-motorized safety performance, and replacing the existing pedestrian signal heads with

count down heads would provide additional guidance to pedestrians attempting to cross this complex urban intersection.

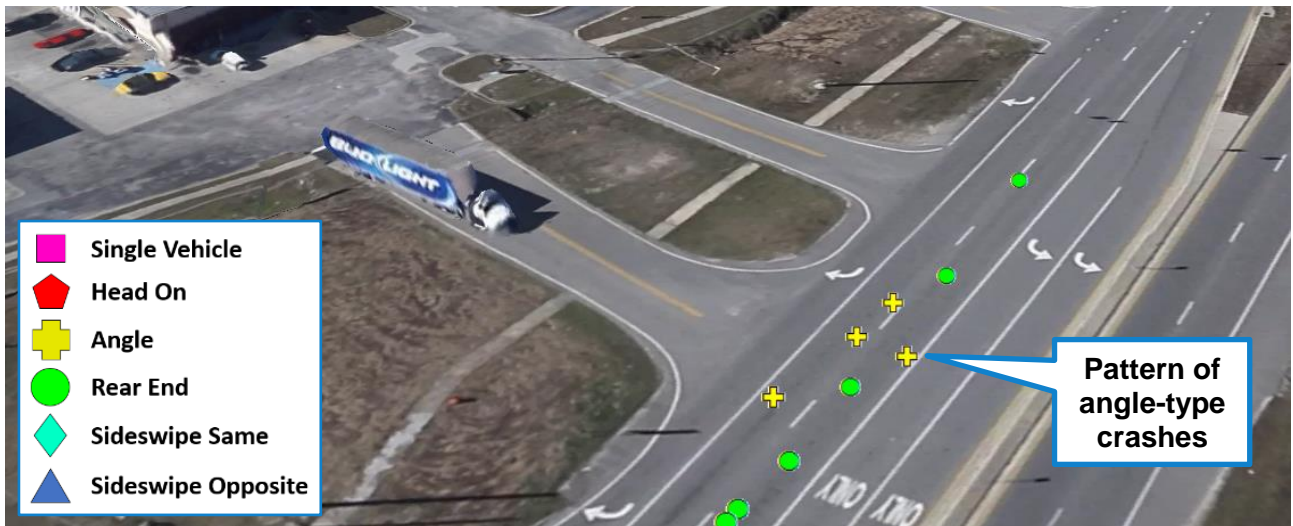
Figure 31: View of Northern Leg of Elma G. Miles and Veterans Parkway Intersection

Due to the relatively high access point density present along this portion of SR 196, there are driveways located within the functional area of the signalized intersection. In particular, the gas station driveways located on the north leg of the intersection represent a potential safety concern. This is evidenced by the fact that four angle-type crashes occurred during the five-year study period involving vehicles entering or exiting these driveways (shown in **Figure 31**).
