Road Safety Audit: State Route 196/Elma G. Miles Parkway

*From Live Oak Church Road
to Veterans Parkway*

Hinesville, GA (Liberty County)

April 18, 2017

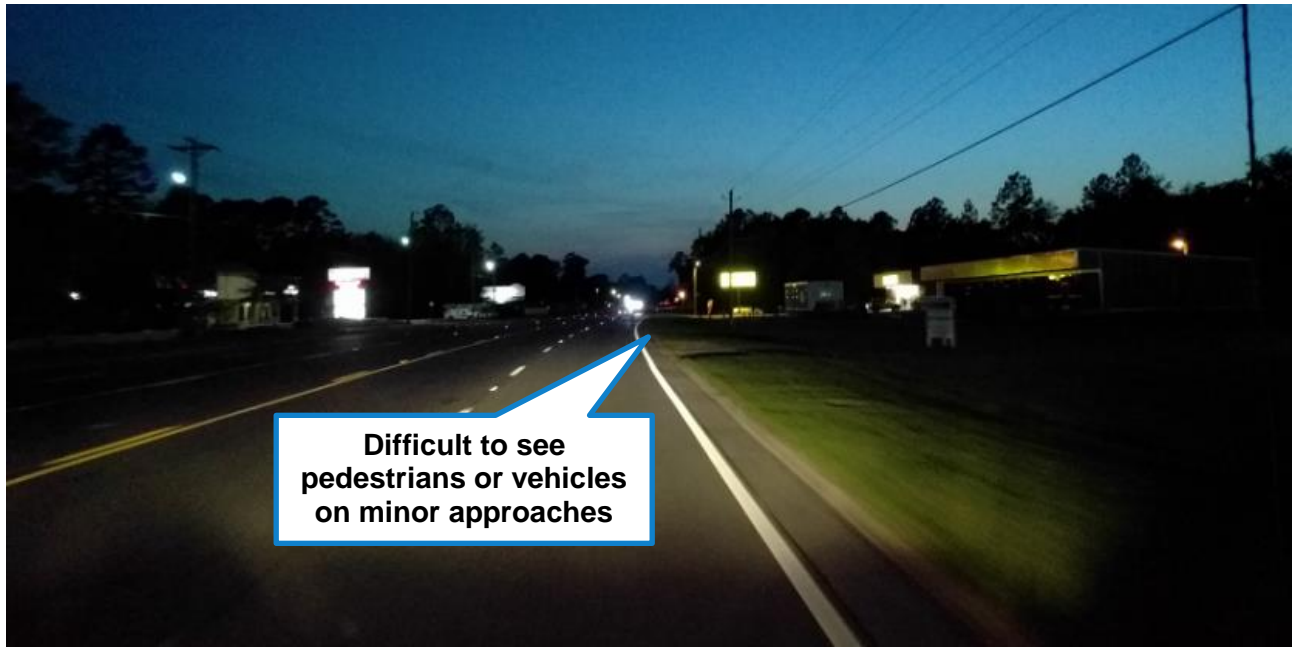
The lack of ambient lighting is a primary concern along this portion of the corridor, potentially resulting in single vehicle run-off-the-road crashes and multiple vehicle collisions as well as crashes involving non-motorized road users. A view from a vehicle traveling westbound along SR 196 at night is shown in **Figure 18**.

Figure 18: View from Vehicle Traveling Westbound on SR 196 at Night

The installation of lighting along this area of the corridor would provide notable safety benefits, addressing all potential crash types occurring at night. This treatment is particularly important in improving the roadway environment for pedestrians and bicyclists, and would complement all the recommendations provided in **Table 10**.

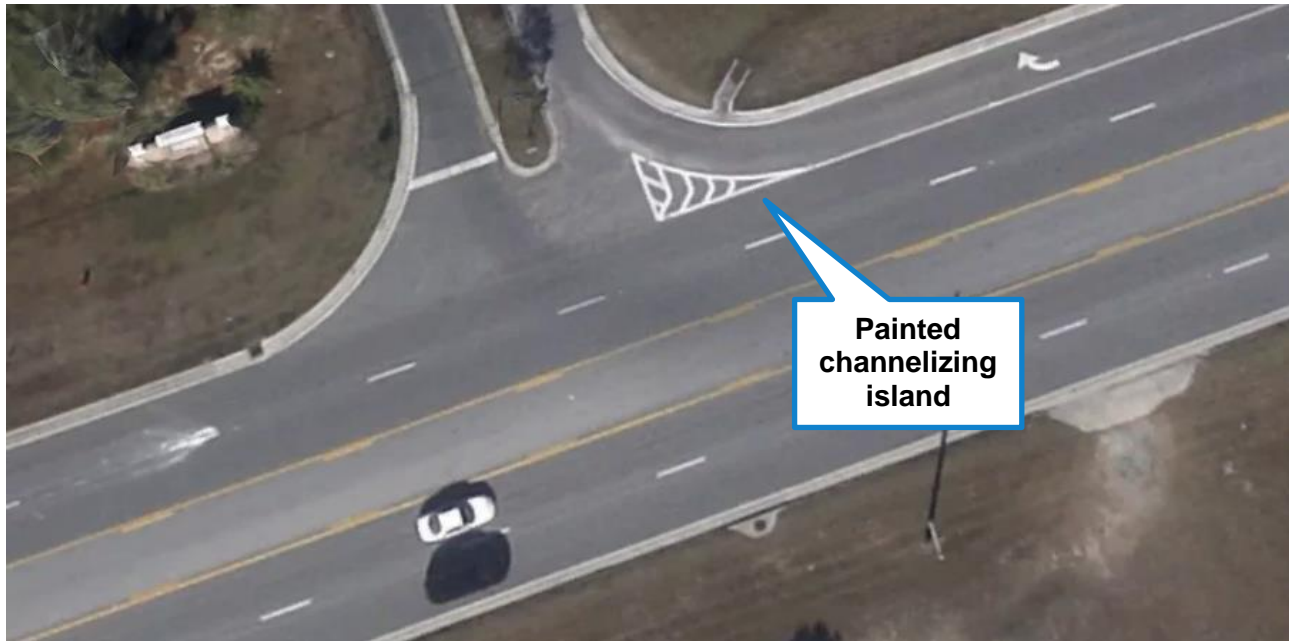
The relatively high speeds observed along the corridor, evidenced by the 49 MPH 85th percentile speeds identified using the HAMPO data, represent a safety concern for all types of traffic crashes. This is an especially important consideration given the lack of ambient lighting. This combination, along with other site characteristics, results in particularly challenging turning movements in and out of minor street driveways and intersections along the this portion of the corridor. This has resulted in a significant number of angle-type crashes, which often result in severe injury outcomes to crash-involved occupants, as evidenced by the concentration of severe crashes in this area. Finally, the channelizing right-turn island at the intersection with Miles Crossing is implemented via pavement markings with a higher deflection angle (shown in **Figure 19**). More recent designs from GDOT include a raised concrete island with deflection angles that allow drivers to more easily identify conflicting vehicles while completing their right-turning movement.

Figure 19: Satellite View of SR 196 and Miles Crossing Intersection

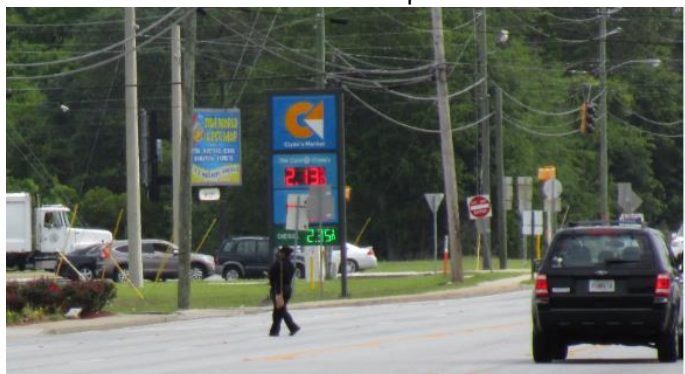
Figure 21: Pedestrian Crossing SR 196 during RSA

on either side of SR 196 and both pedestrians and bicyclists have been observed crossing SR 196 at unmarked locations (**Figure 21**).

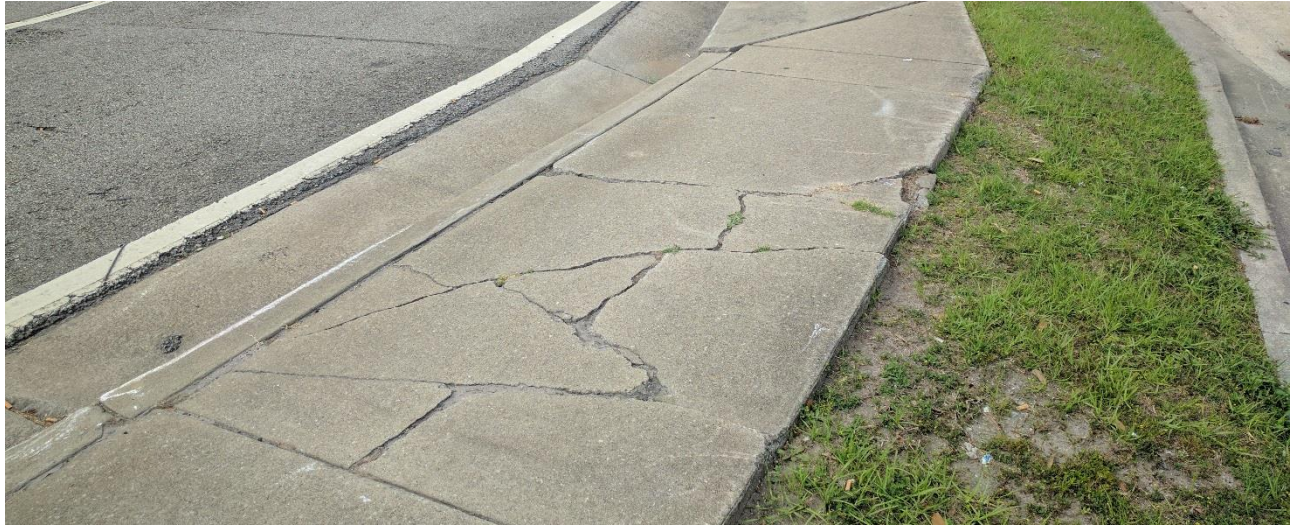
This is also evidenced by the two pedestrian fatalities that occurred adjacent to Hearn Road, along with the concentration of bicycle-involved crashes that occurred just west of the signalized intersection with Veterans Parkway. Sidewalks along this portion of the corridor are also in need of repair, such as the location on the north side of SR 196 adjacent to the McDonalds Restaurant shown in **Figure 22**.

Figure 22: View of Sidewalk Needing Repair along Eastern Portion of SR 196 Study Corridor

- Repairing damaged sidewalk and signage along the corridor,
- Ensuring that sufficient width is available along existing sidewalks,
- Replacing a painted channelizing island at Miles Crossing,
- Relocating W3-3 Signal Ahead warning signs at Veterans Parkway farther upstream, and
- Performing a signal timing study to reduce queueing at Veterans Parkway.

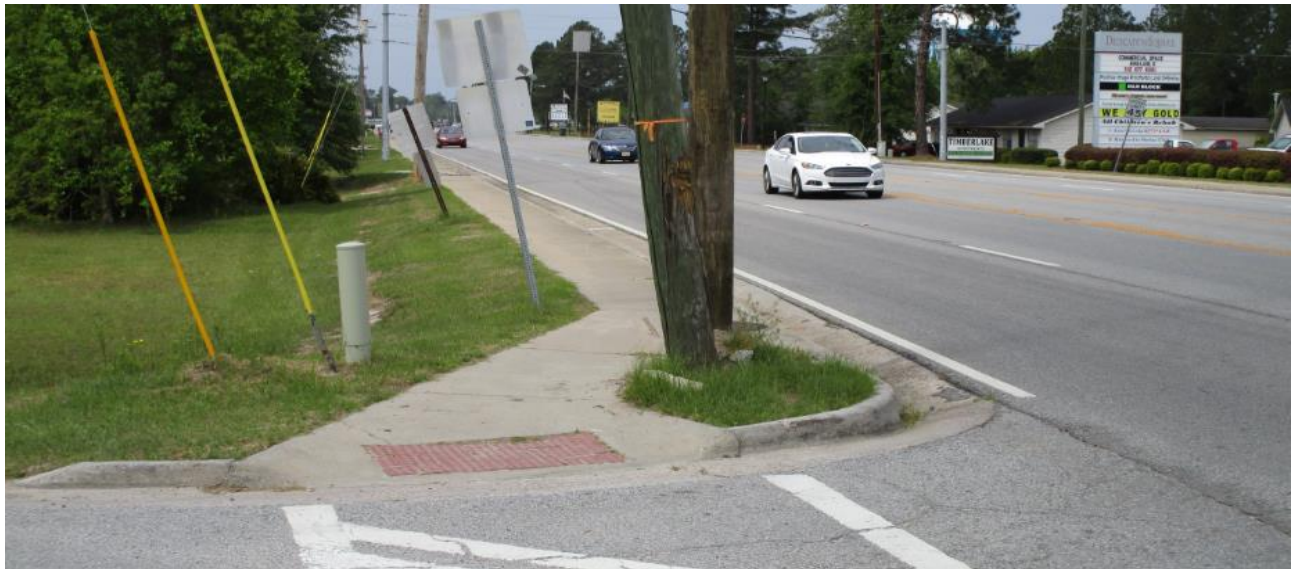
Conflicts between pedestrians and bicyclists have also been observed due to the limited available sidewalk width, particularly at minor street intersection approaches (**Figure 23**).

Figure 23: View of Crosswalk along SR 196 with Limited Width

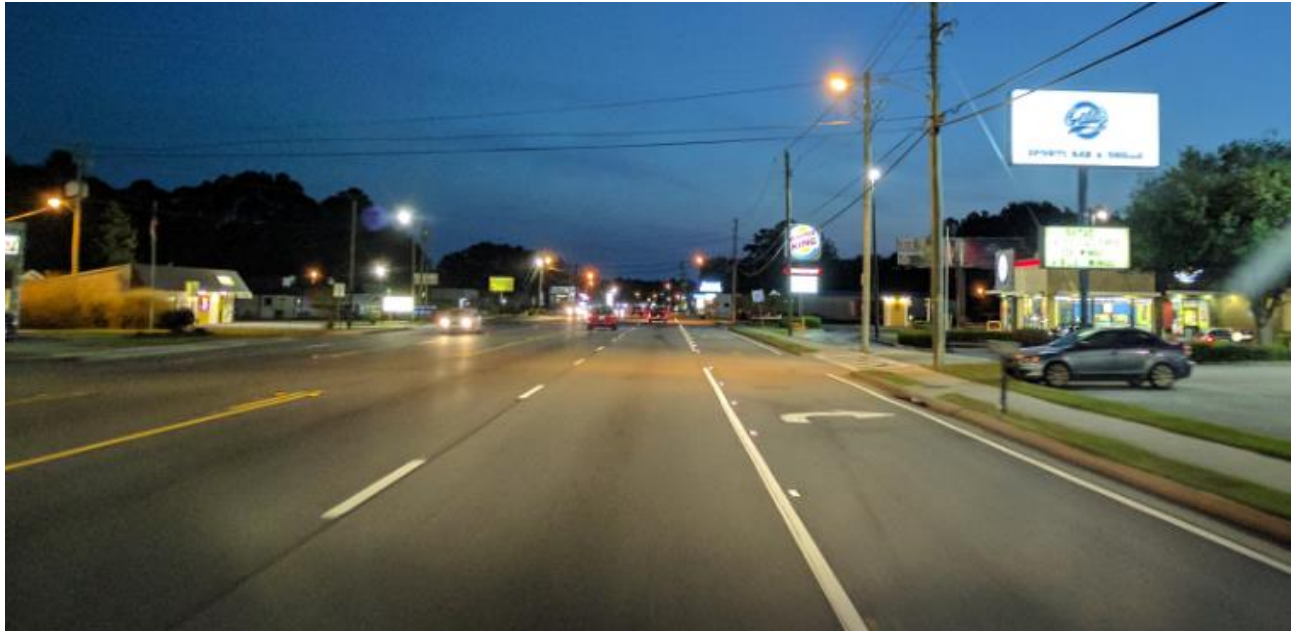
While the level of ambient lighting is significantly higher along the eastern portion of the corridor due to the presence of the adjacent commercial developments (**Figure 24**), lighting remains a concern, particularly in relation to non-motorized road users.

Figure 24: View of Westbound SR 196 at Night

Installing lighting along this section of the corridor would provide notable safety benefits, addressing all potential crash types occurring at night. This treatment is particularly important in improving the roadway environment for pedestrians and bicyclists, and would complement all the recommendations provided in **Table 12**. Repairing the damaged sidewalks along the corridor and ensuring adequate width would support non-motorized road users, representing low-cost, short-term improvements that can provide moderate safety benefits.

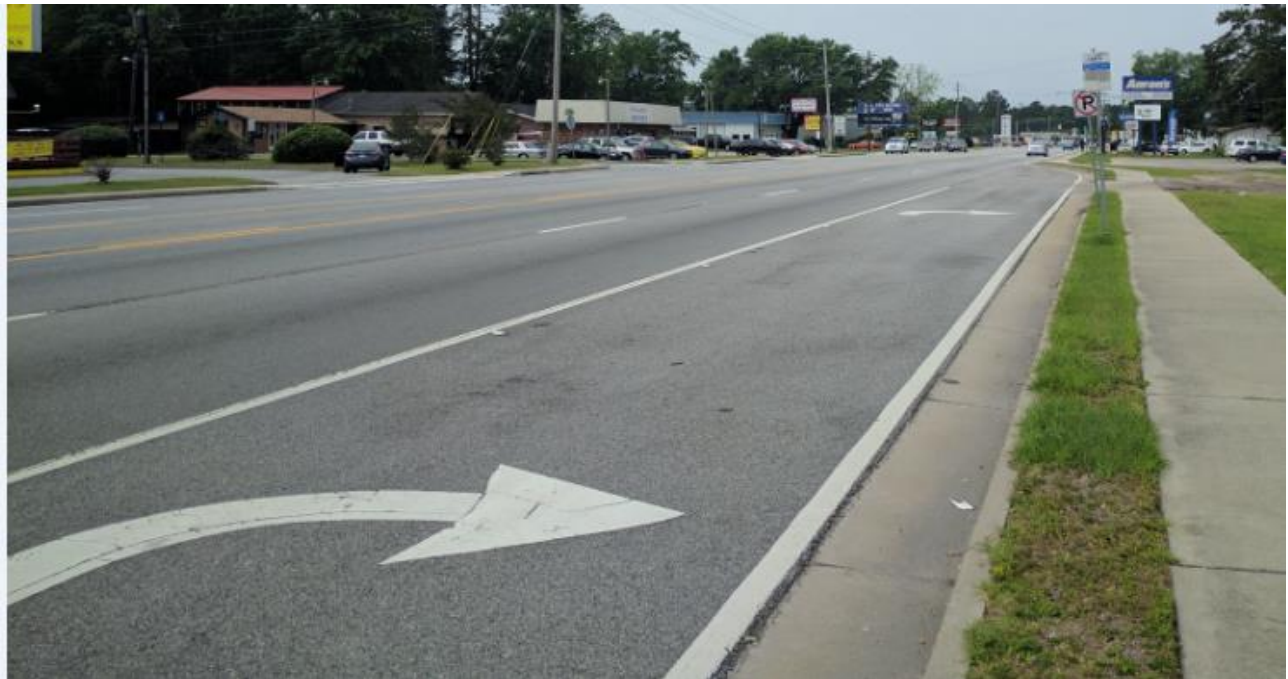
The exclusive right-turn lane located on the north side of SR 196 on the eastern edge of the corridor spans more than 1,000 feet and incorporates three commercial driveways and a stop-controlled intersection. As a result, traffic conflicts were observed during the RSA field visit related to vehicles entering the exclusive right-turn lane well before their intended destination. Additionally, the existing downstream terminus, which extends approximately 275 feet beyond the intersection with Sharon Street, results in drivers using this lane as an acceleration lane to merge with westbound SR 196 traffic (**Figure 25**).

Figure 25: View of Exclusive Right-Turn Lane on North Side of SR 196

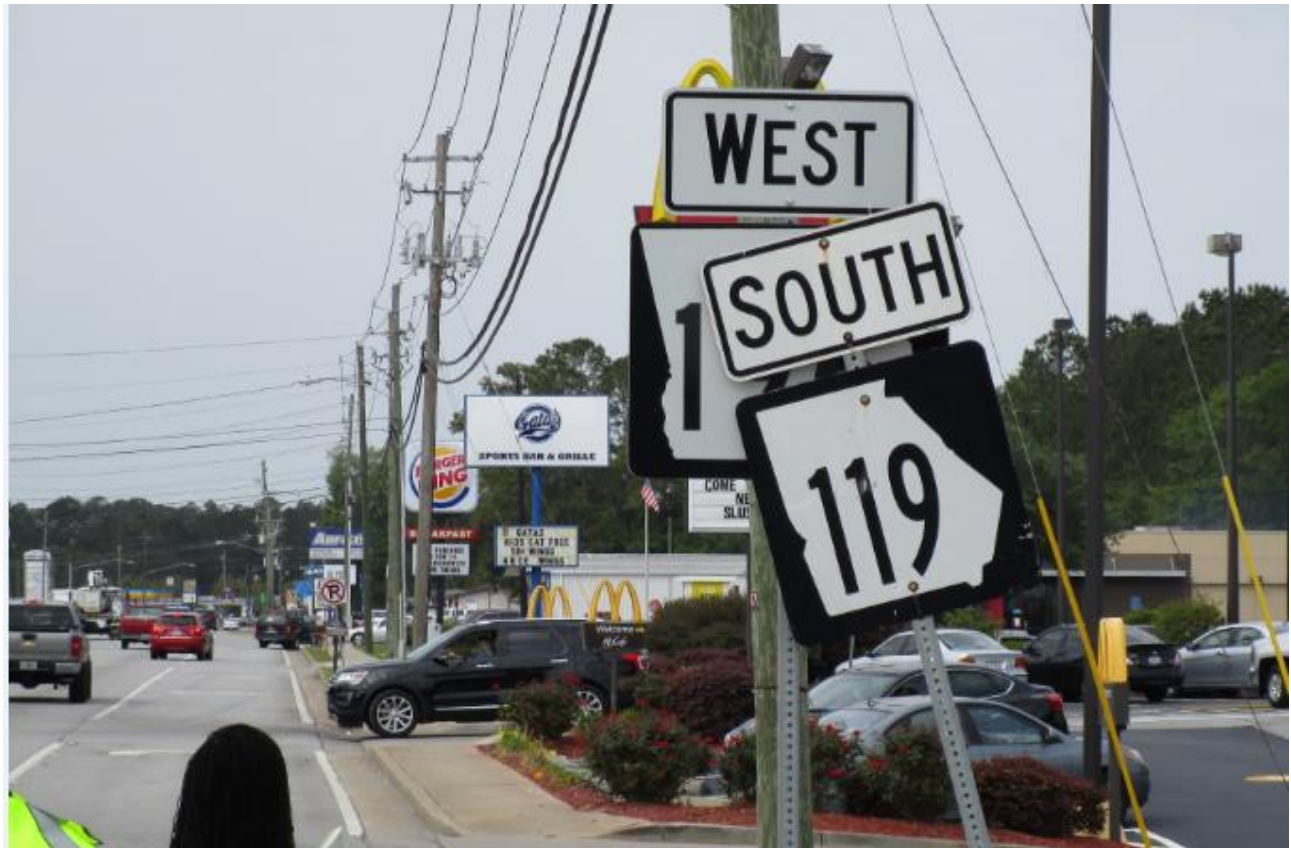
State route guidance signs located on the north side of SR 196 and west of Veterans Parkway appeared to be previously struck by a vehicle and are misaligned (**Figure 26**).

Figure 26: View of Misaligned State Route Guidance Signs on North Side of SR 196

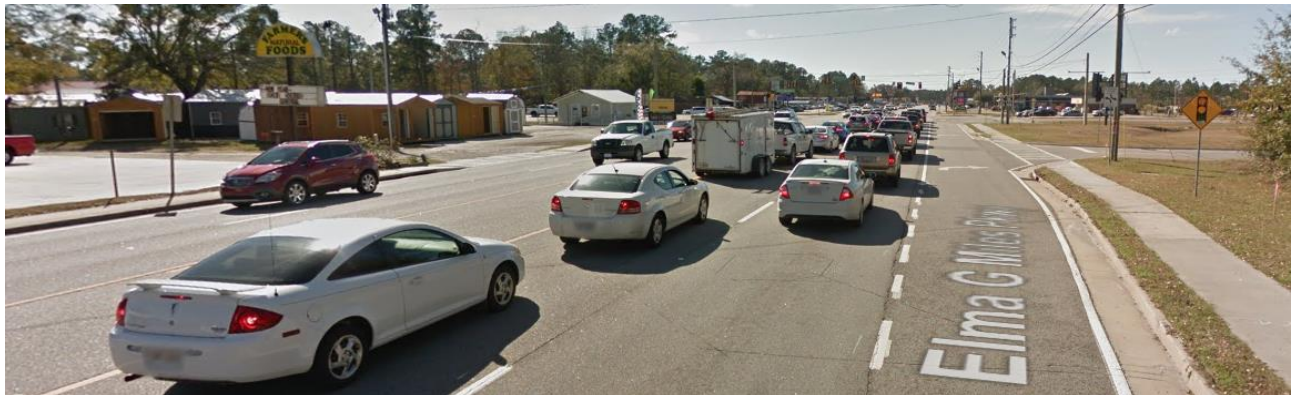
Approach speeds to the intersection were noted to be relatively high during the RSA process, a concern that is evidenced by the fact that 140 of the 187 crashes that occurred at this location were rear end in nature. The combination of the relatively high approach speeds with the queues that form during the peak hours at this location (shown in **Figure 27**) compound this concern, leading to the noted pattern of rear end crashes.

Figure 27: View of Westbound SR 196 at Veterans Parkway Intersection

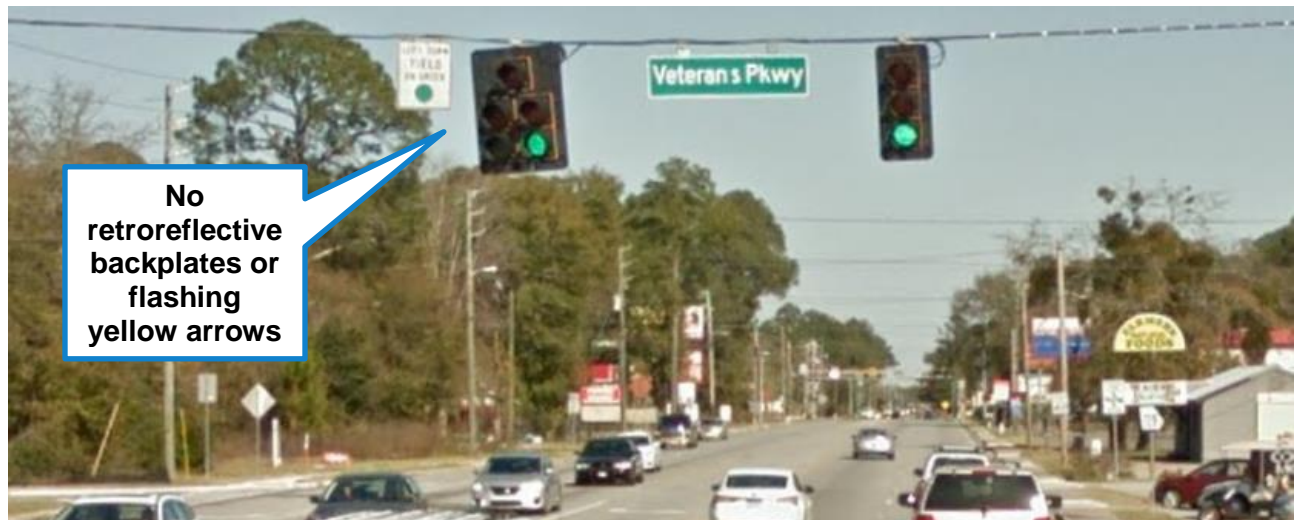
The existing traffic signal heads at the intersection do not include retroreflective backplates (shown in **Figure 28**). Additionally, four-level flashing yellow arrow signal heads are not included for the eastbound and westbound left-turn movements, as the existing signal heads employ the dog-house design. Supplementary signal heads are also not present, which may help to provide additional guidance to drivers attempting to complete left-turn movements.

Figure 28: View of Eastbound Signal Heads at Veterans Parkway Intersection

The installation of retroreflective backplates, supplementary signal heads, and flashing yellow arrows for the eastbound and westbound left-turn signal heads would also help to improve traffic signal conspicuity, providing additional guidance to drivers in this complex visual environment. It should be noted that the recommended signal treatments may not be appropriate in combination with recommendations #21 and #23. A review of the existing signal timing may also identify opportunities to reduce queuing to address safety issue #21.

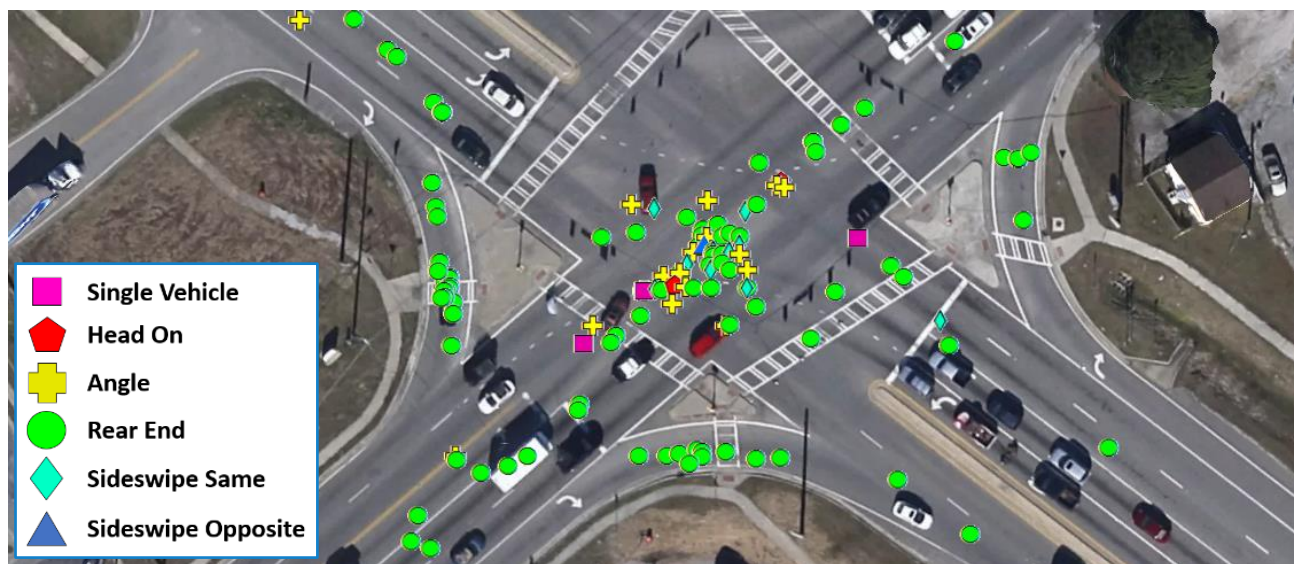
The existing raised concrete channelizing islands were implemented with a higher deflection angle that can result in drivers having to look over their shoulder to observe conflicting traffic. As a result, a pattern of rear end crashes within the channelized right-turn lanes was observed during the five-year study period (**Figure 29**).

Figure 29: Pattern of Rear End Crashes in Channelized Right-Turn Lanes (2012-2016)

The implementation of 30-60-90 degree raised concrete channelizing islands would represent a significant improvement over the existing condition, helping to address the pattern of rear end-type crashes shown in **Figure 29**. Consolidating driveways within the functional area of the intersection, specifically the gas station driveways located on the northern leg, would directly help to address the crash pattern shown in **Figure 31**.

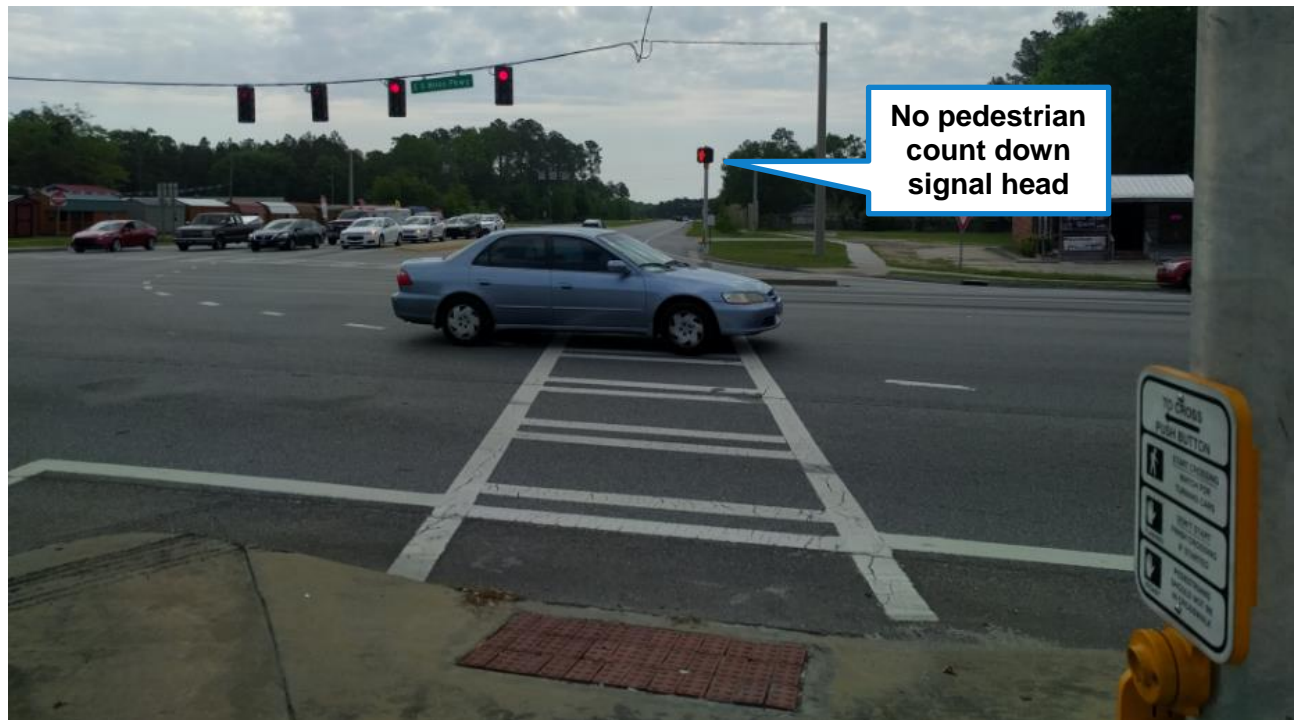
While pedestrian signal heads and push button actuation are present at this location, pedestrian count down signal heads have not been included (**Figure 30**). The RSA team determined the crosswalks and ADA-complaint ramps present at this location are in good condition.

Figure 30: View of Pedestrian Signal Head and Push Button Actuation

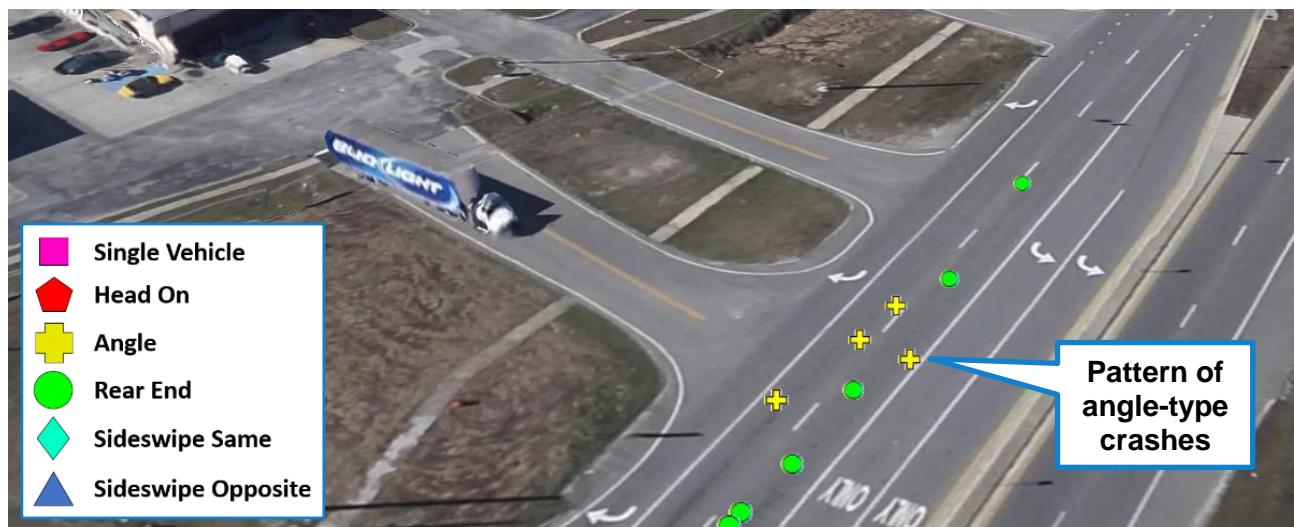
Due to the relatively high access point density present along this portion of SR 196, there are driveways located within the functional area of the signalized intersection. In particular, the gas station driveways located on the north leg of the intersection represent a potential safety concern. This is evidenced by the fact that four angle-type crashes occurred during the five-year study period involving vehicles entering or exiting these driveways (shown in **Figure 31**).

Figure 31: View of Northern Leg of Elma G. Miles and Veterans Parkway Intersection

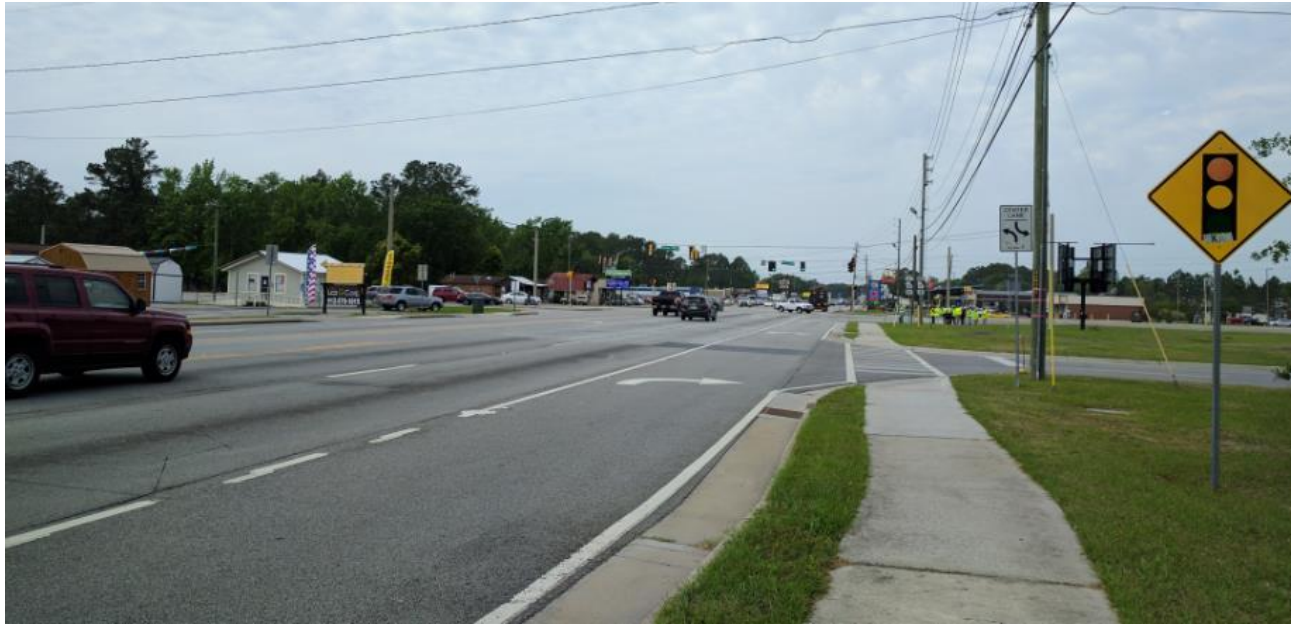
While the W3-3 Signal Ahead warning signs are placed along each approach to the intersection, these devices are past their useful service life and are not providing appropriate retro-reflectivity (**Figure 32**). Additionally, these devices are located too far downstream to provide the necessary warning to drivers of the upcoming intersection, especially considering the queues often observed during the peak hour (an example of vehicles queued beyond the W3-3 sign is shown in **Figure 27**).

Figure 32: View of Westbound SR 196 at Veterans Parkway Intersection

The existing W3-3 Signal Ahead warning signs are beyond their useful service life; replacing these signs would greatly improve their conspicuity, especially under dark conditions. Further, relocating these devices farther upstream would provide additional guidance to drivers of the upcoming signalized intersection. This would directly help to address safety issues #18, #21 and #25. It should be noted that the bicycle lane alternative identified for the eastern portion of the SR 196 corridor would also help to address safety issue #18 related to high approach speeds on the western leg.
