Road Safety Audit: State Route 196/Elma G. Miles Parkway

*From Live Oak Church Road
to Veterans Parkway*

Hinesville, GA (Liberty County)

April 18, 2017

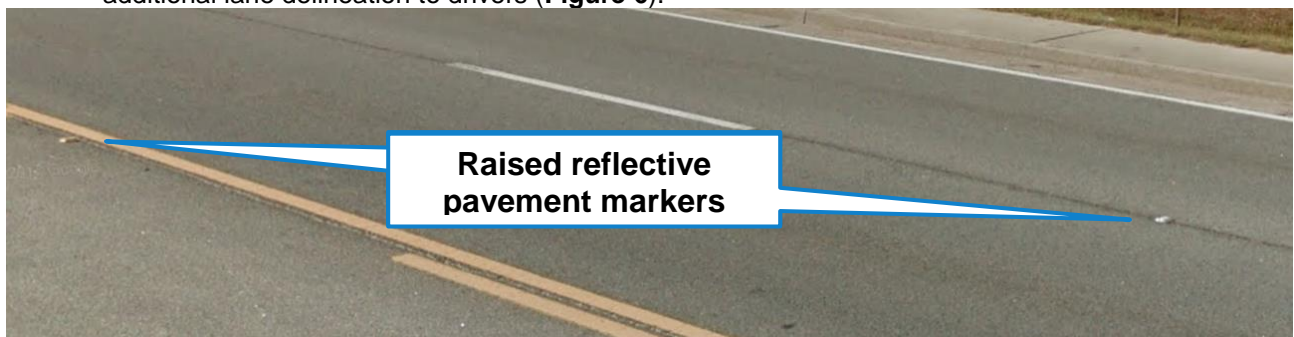
Figure 6: View of Raised Reflective Pavement Markers along SR 196

- Raised reflective pavement markers are included along the striped lane pavement markings to provide additional lane delineation to drivers (**Figure 6**).

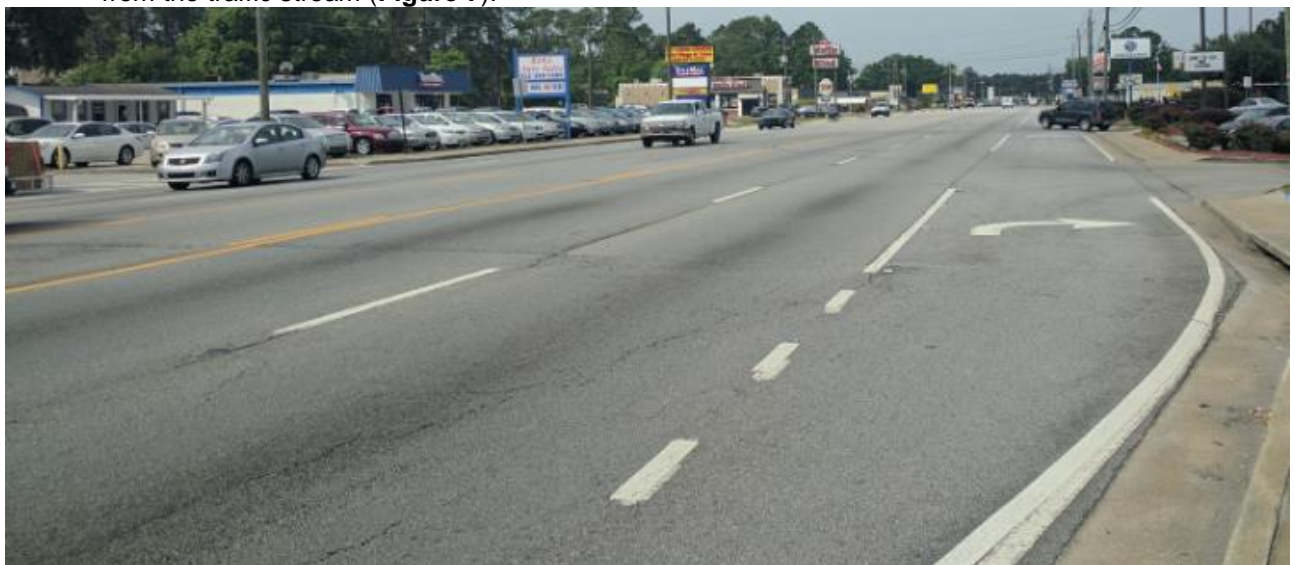
Figure 7: View of Exclusive Right-Turn Lane along SR 196

- Exclusive right-turn lanes in certain locations to separate vehicles making right-turning movements from the traffic stream (**Figure 7**).

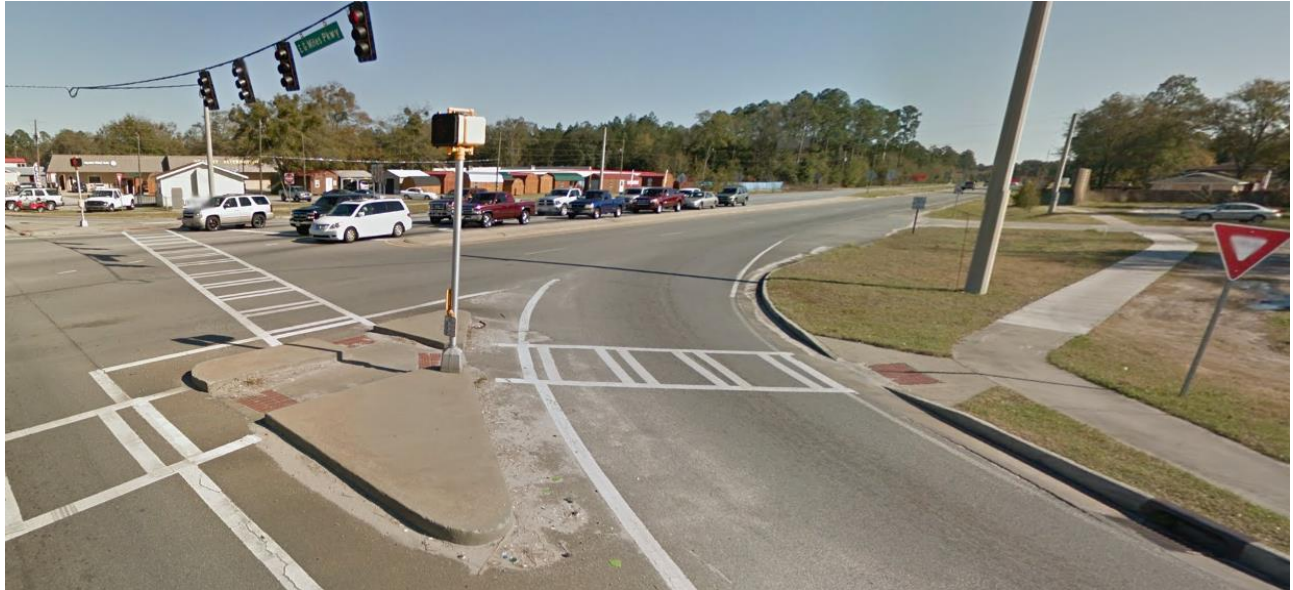
Figure 8: View of Raised Concrete Islands and Pedestrian Facilities at Veterans Parkway Intersection

- The signalized intersection at Veterans Parkway includes a variety of existing safety features. Raised concrete islands are included for three of the four quadrants, helping to channelize right-turning movements and providing refuge for pedestrians attempting to cross either SR 196 or Veterans Parkway (**Figure 8**). Additionally, this intersection incorporates Americans with Disabilities Act- (ADA) compliant pedestrian facilities, including striped crosswalks and pedestrian signal heads with push button actuation (**Figure 8**). Hatched pavement markings are included within the intersection to guide left-turning movements (**Figure 9**). Approaches to the intersection include overhead lane marking signs to provide guidance to drivers as well as W3-3 Signal Ahead warning signs (**Figure 10**). Overhead street name signs are also installed at the intersection to provide additional guidance to drivers. It should also be noted that Veterans Parkway maintains its divided nature on either side of SR 196.

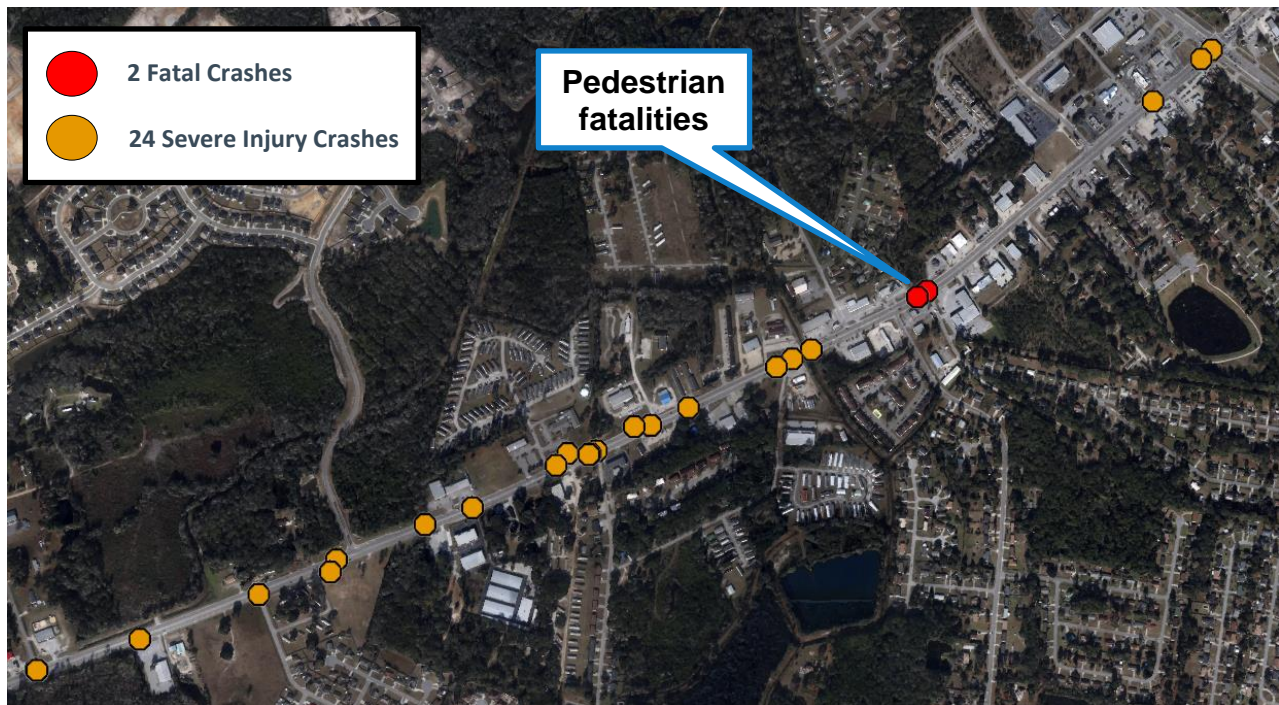
Figure 11: Location of Fatal and Severe Injury Crashes (2012-2016)

Both fatal collisions involved pedestrians attempting to cross SR 196 adjacent to Hearn Road at night. The first fatality occurred in May 2013 involving a vehicle traveling westbound along SR 196 and colliding with a pedestrian attempting to cross from north to south. The second fatality occurred in December 2016 involving a pedestrian attempting to cross SR 196 from south to north and being struck by an eastbound vehicle. A majority of severe crashes are distributed in the western portion of the corridor where vehicular speeds are higher. The location of pedestrian and bicycle crashes occurring along the study corridor during the five-year study period is shown in **Figure 12**.

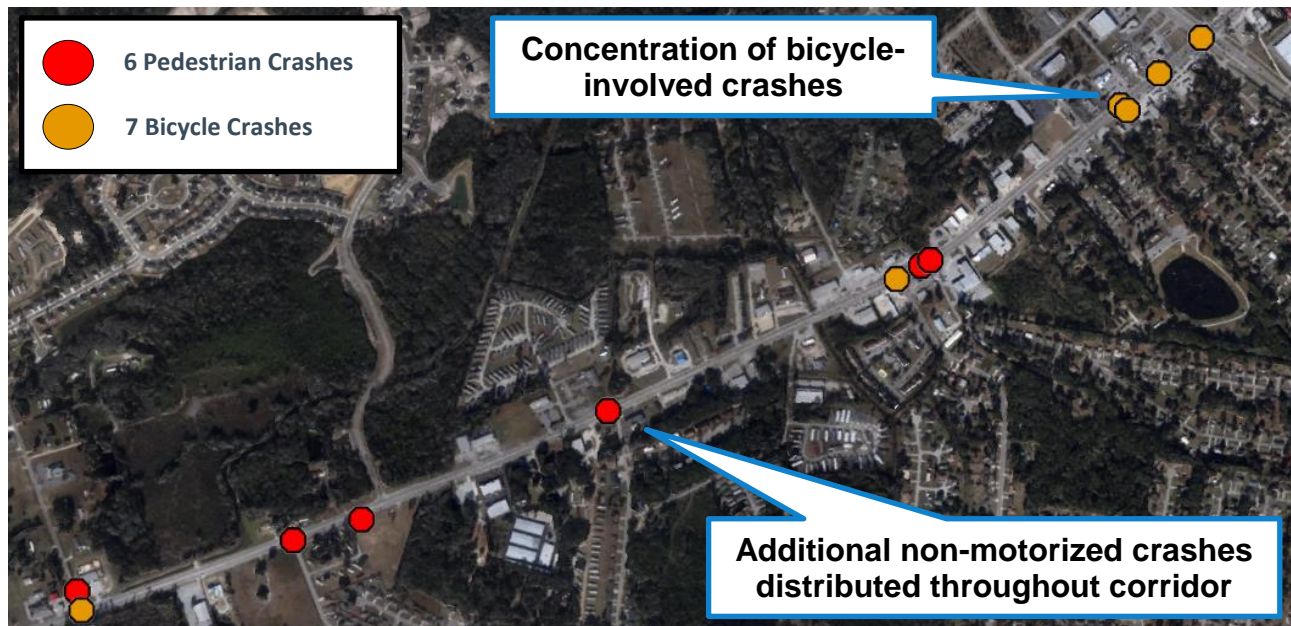
Figure 12: Location of Pedestrian and Bicycle Crashes (2012-2016)

As shown in **Figure 12**, a concentration of bicycle-involved crashes occurred at the eastern edge of the corridor. The confluence of adjacent restaurants and other destinations with the surrounding residential developments results in this portion of the corridor observing frequent bicycle traffic. The remaining non-motorized crashes are distributed through the study corridor, including the two fatalities and additional collisions due to non-motorized users attempting to cross SR 196 at uncontrolled locations. The fact that SR 196 remains uncontrolled for approximately 2.5 miles from Veterans Parkway to Airport Road represents a significant challenge to non-motorized users attempting to safely cross the five-lane arterial. A heat map of all crashes occurring during the five-year study period is presented in **Figure 13**.

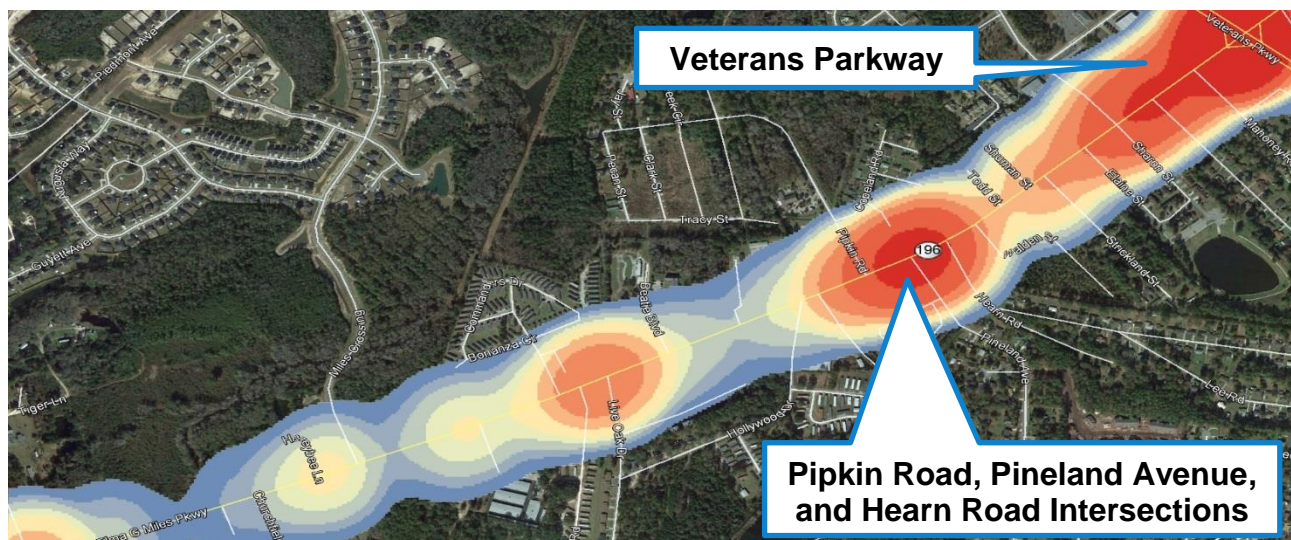
Figure 13: Heat Map of All Crashes (2012-2016)

The highest concentration of crashes occurred at the eastern end of the corridor adjacent to the signalized intersection with Veterans Parkway. This is due in part to the relatively high density of commercial driveways that serve significant entering and exiting traffic, and the presence of the signalized intersection. An additional hot spot is observed at the stretch where the minor approach stop-controlled intersections with Pipkin Road, Pineland Avenue, and Hearn Road are closely spaced along a gentle horizontal curve.

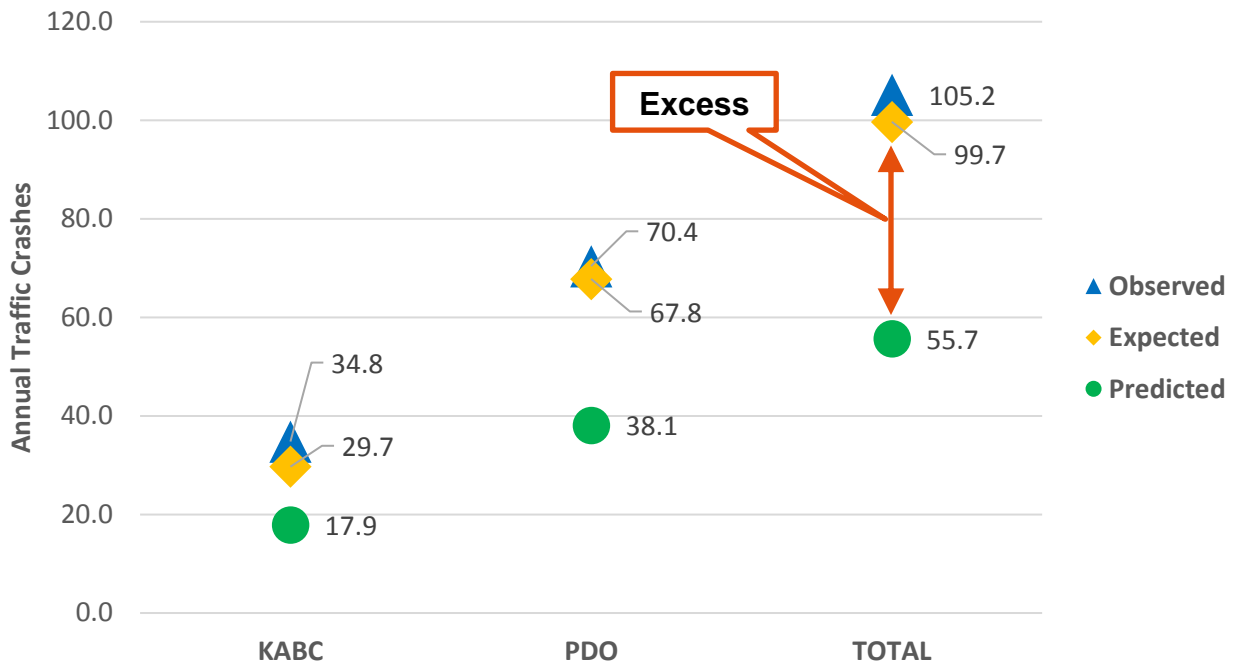
**Figure 14: Summary of EB-Method Analysis Results – SR 196 Corridor (2012-2016)**

The corridor observed an annual average of 105.2 crashes, including 34.8 crashes resulting in a fatality or injury to a crash-involved occupant. These values greatly exceed the predicted frequencies developed using the models in the HSM. After combining the observed and predicted frequencies using the EB-method, the corridor is expected to observe 29.7 KABC crashes and 99.7 total crashes annually. These values also greatly exceed the predicted values developed using the models in the HSM, demonstrating annual excesses of 11.8 KABC crashes and 44.0 total crashes. This suggests that there is significant opportunity to improve safety performance along the study corridor with appropriate treatments and countermeasures. The annual expected and predicted crashes for each corridor segment and intersection are presented in **Figures 15 (segments) and 16 (intersections)**.

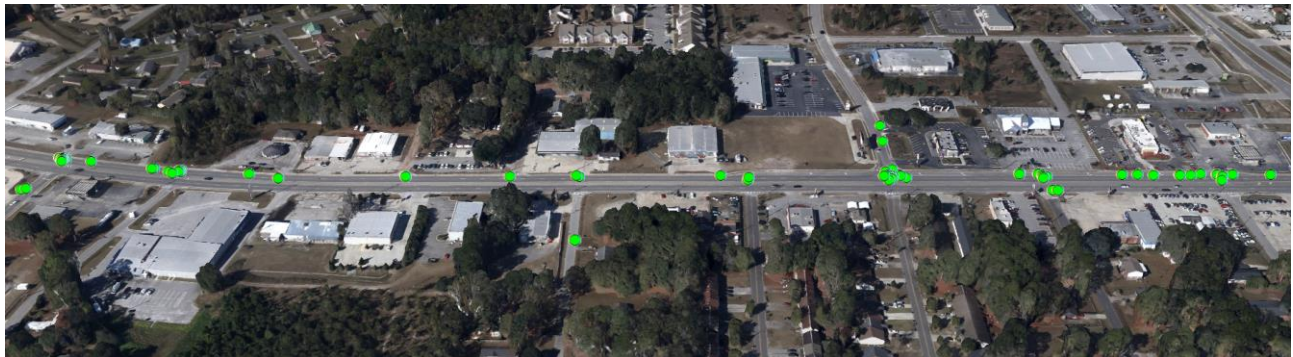
Figure 20: Location of Angle-Type Crashes Occurring on Eastern Portion of Study Corridor

The relatively high density of minor approach stop-controlled intersections and commercial driveways along the eastern portion of the corridor create a challenging environment for both motorized and non-motorized road users. In particular, difficult left-turning movements in and out of both the intersections and driveways results in an elevated risk for angle-type crashes along this portion of the corridor. This is evidenced by the significant number of angle-type crashes that occurred along this portion of the corridor during the five-year study period. This included 113 angle-type crashes out of the 241 total crashes (or 47 percent) that occurred on this portion of the corridor; **Figure 20** shows their locations.

As can be seen from **Figure 20**, angle-type crashes are distributed throughout the eastern portion of the corridor and are most prominent adjacent to intersections and commercial access points. Treatments and countermeasures to improve safety specific to this portion of the study corridor should particularly address this crash pattern.
